DOE/NASA/20320-63
NASA TM-86983

Government Review of the Mod-2 Wind Turbine (As-Built)

June 1985

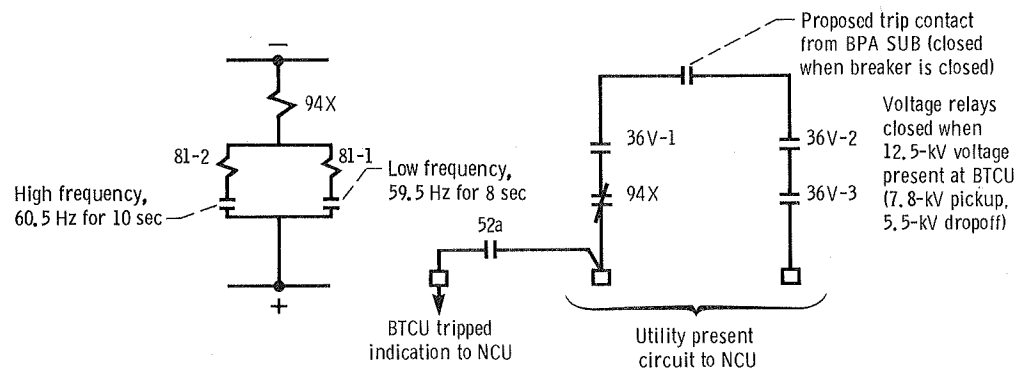
Figure 21. - Loss of utility power relay trip circuit.

The signal from these relays is used by the nacelle control unit (NCU) to indicate an absence of utility power. A significant amount of time (ranging from 8 sec to more than 1 min) can pass before the NCU senses and responds to a loss of utility power. An added trip contact placed in series with the contacts of relays 94X and 36V (see fig. 21) would provide an immediate signal to the NCU of loss of utility power resulting in WT shutdown.

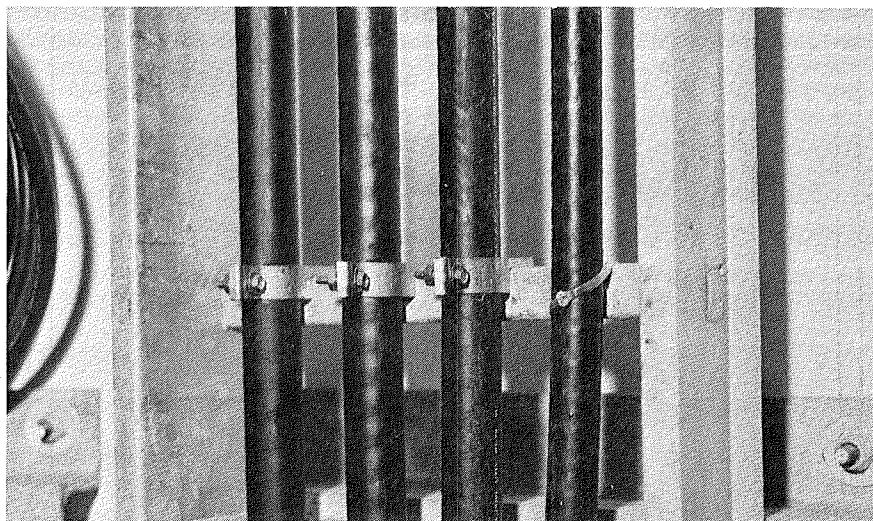
Figure 22. - Phase conductor (4, 16-kV) cable ladder clamps.

Item No. 22 - Tower Power Cable Mountings. - Three individually jacketed cables are used to carry the 4.16-kV alternator output to the base of the tower. These conductors are secured by individual metal clamps (see fig. 22) to the cable ladder. These clamps are placed about 1.5 ft apart, at every

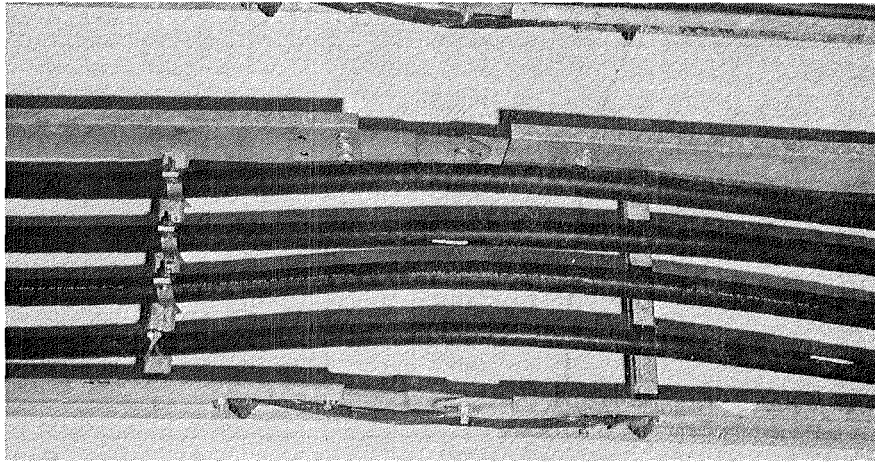
Figure 23. - Power cable ladder extension joints.

ladder rung, except one rung is skipped at the cable ladder extension joints (every 12 ft) (see fig. 23). Nylon tie-wraps are used to secure the 2/0 neutral cable to the ladder.

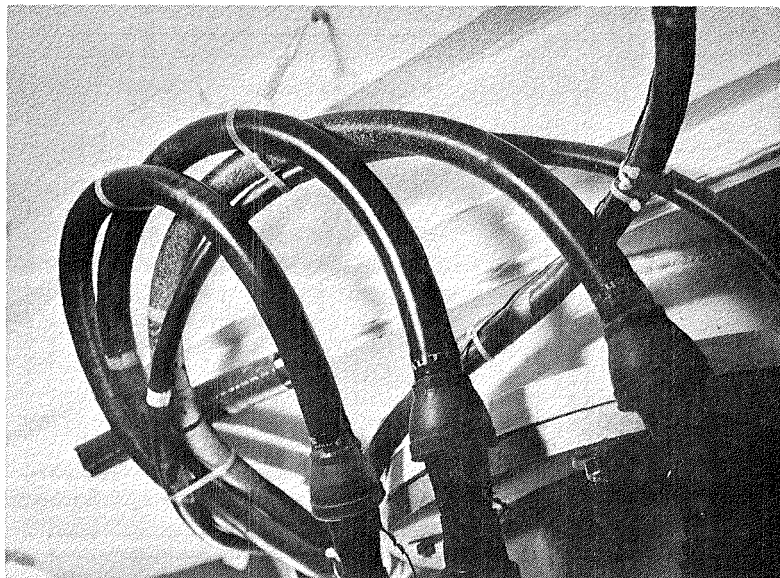
Figure 24. - Wind turbine HV cable suspension at yaw slipring.

Findings: The high voltage power cables which run from the generator to the yaw slipring assembly had a free run of about 5 ft in length between the point where they emerge from the nacelle floor conduit and attach to the slip ring terminations. The three phase conductors were tied off and supported by a nylon rope in WT3 and nylon tie-wrap in WT2 (see figure 24). The suspension tether supported the conductor weight and relieves strain on the rotation side termination elbows. WT1 was partially disassembled following the LSS failure in November 1982 so its method of suspension could not be determined.

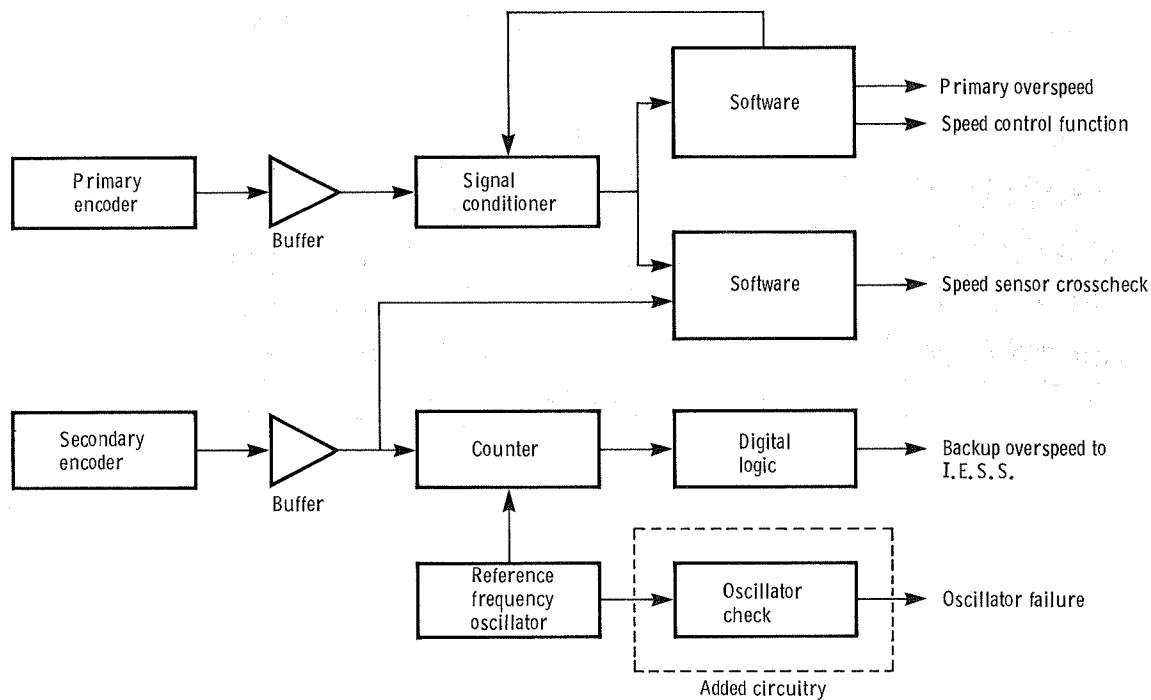
Figure 25. - Overspeed sensing circuitry.

The sensing, shown in figure 25, consists of two encoders of similar but not identical installation and manufacture, thus eliminating the likelihood of simultaneous generic failures. One sensor used for the speed control function, also generates the primary overspeed signal which actuates the start and stop valves. This circuitry, located in the microprocessor rack was used continuously during normal running. Thus, most failures were detectable and failsafe or had a built-in backup mode, such as feathering the blade with servo valves if the start and stop valves did not function.

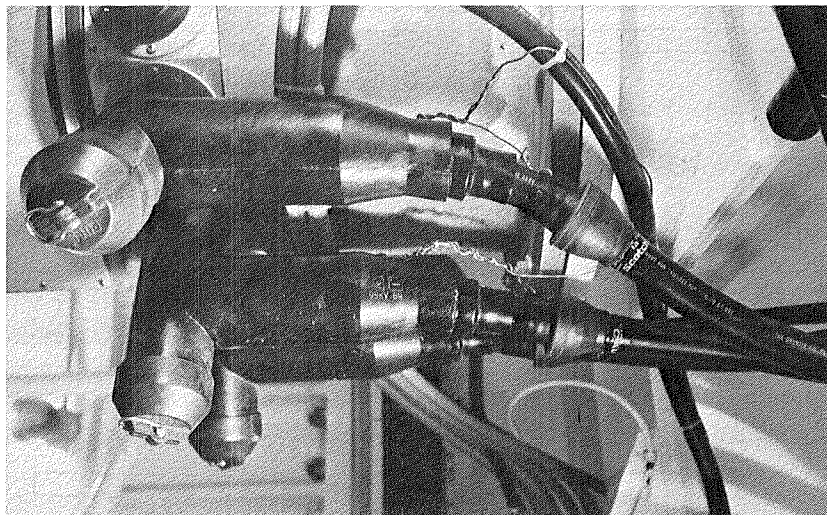
Figure 27. - Wind turbine yaw slipring HV molded cable terminations.

BEC nonconformance reports (NCR's) documented that oil leaks in the nacelle were resulting in oil dripping onto, or potentially dripping onto the HV cables where they attach to the yaw slipring. (See fig. 27.) Oil will eventually deteriorate the insulation of the HV cables, and both the insulation and semiconducting coating of the molded HV connectors, causing faults between phases and from phase to ground.

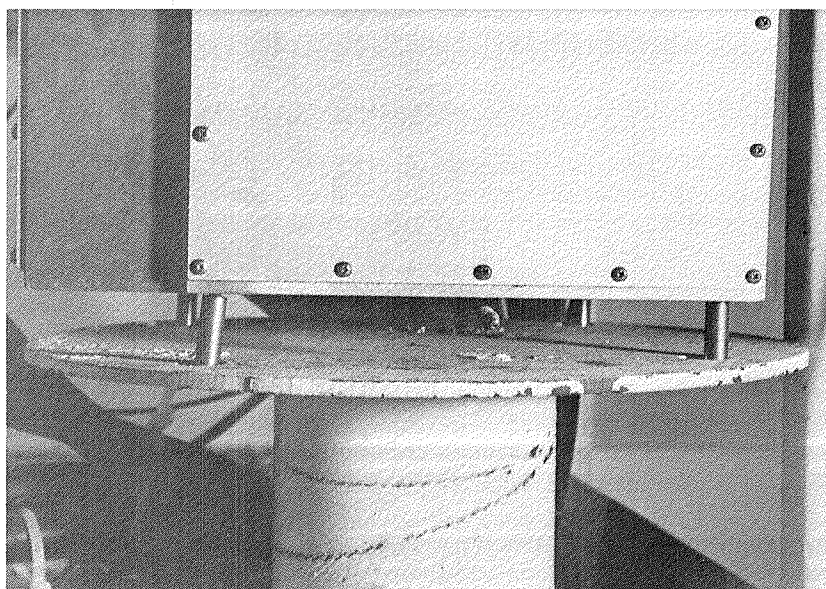
Figure 28. - Wind turbine yaw slipring anti-rotation restraint.

The antirotation bracket on WT2 (see figure 28) showed some deformation where the existing bolts, that act as antirotation restraints were attached. Inspections of this installation and others give the impression that misalignment might exist between the rotating and stationary fixtures of the yaw slipring assembly. This could cause bending loads to be placed on the assembly by the antirotation brackets and bolt restraints.
